THE GENOA

APPROACH

The Genoa Approach

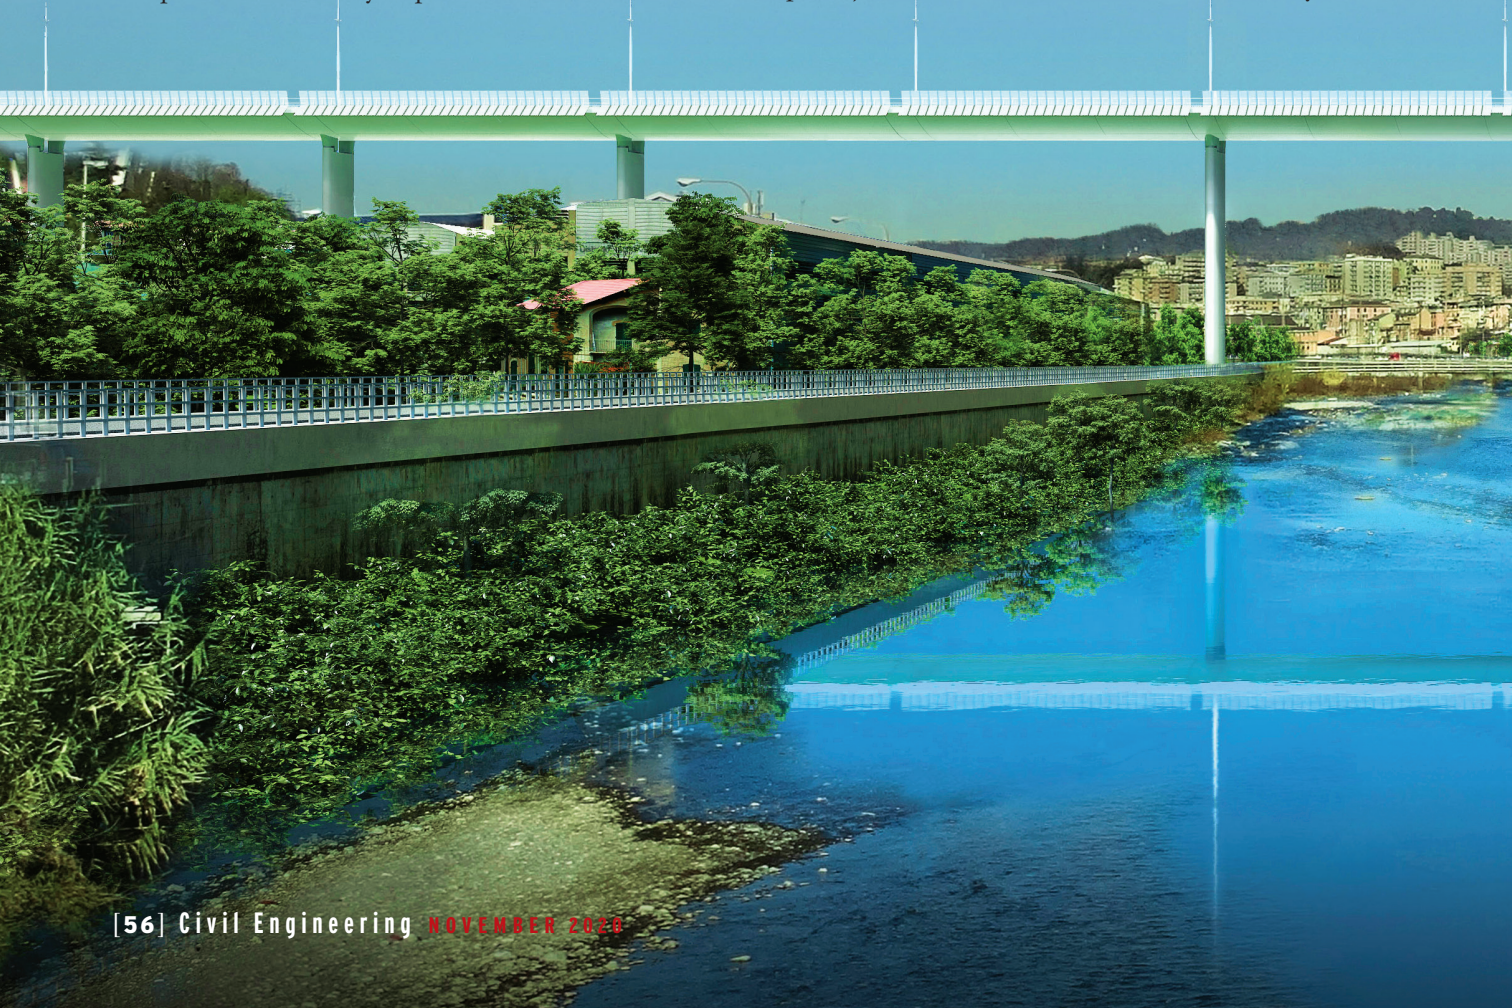
The steel and concrete continuous deck of the Genoa-Saint George Bridge is 1,067 m long. The bridge, which spans the Polcevera, has set new standards in efficiency.

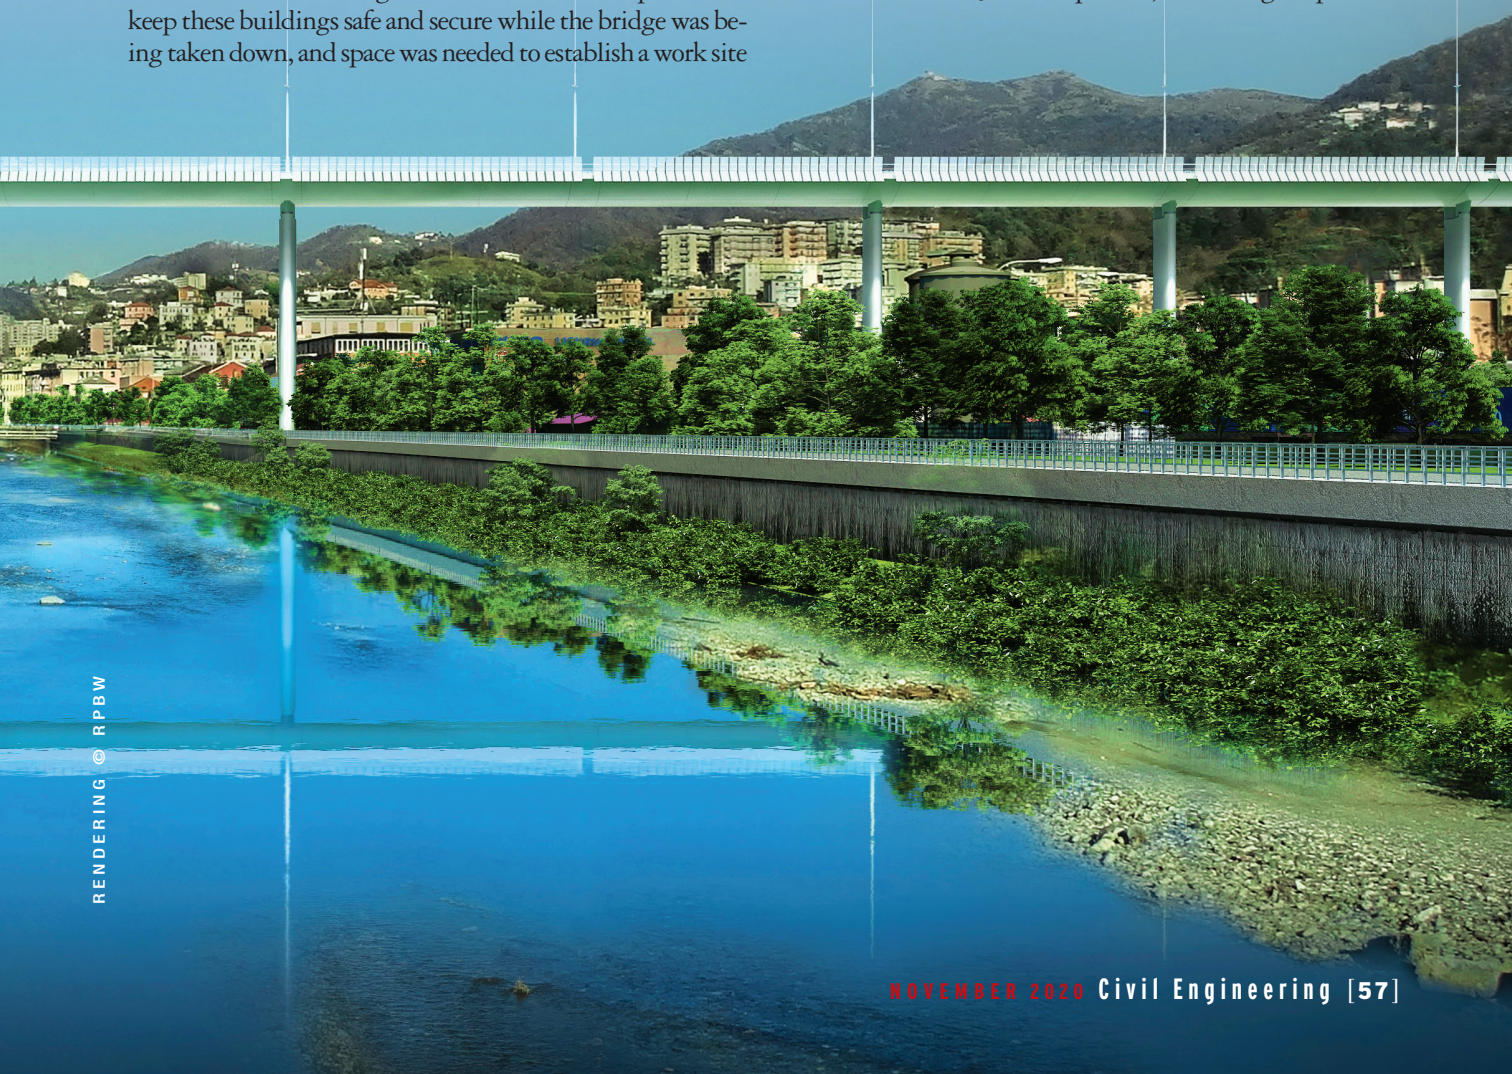
A 400 m perimeter was set up around the sections of the bridge brought down by explosives, above. Sections of the new bridge were assembled on the ground and lifted into place by cranes, below.

Extensive testing was carried out before commencing the explosion, and the results showed that the asbestos levels were insignificant or absent. On the day of the explosion, a 400 m perimeter was set up around this section of the bridge.

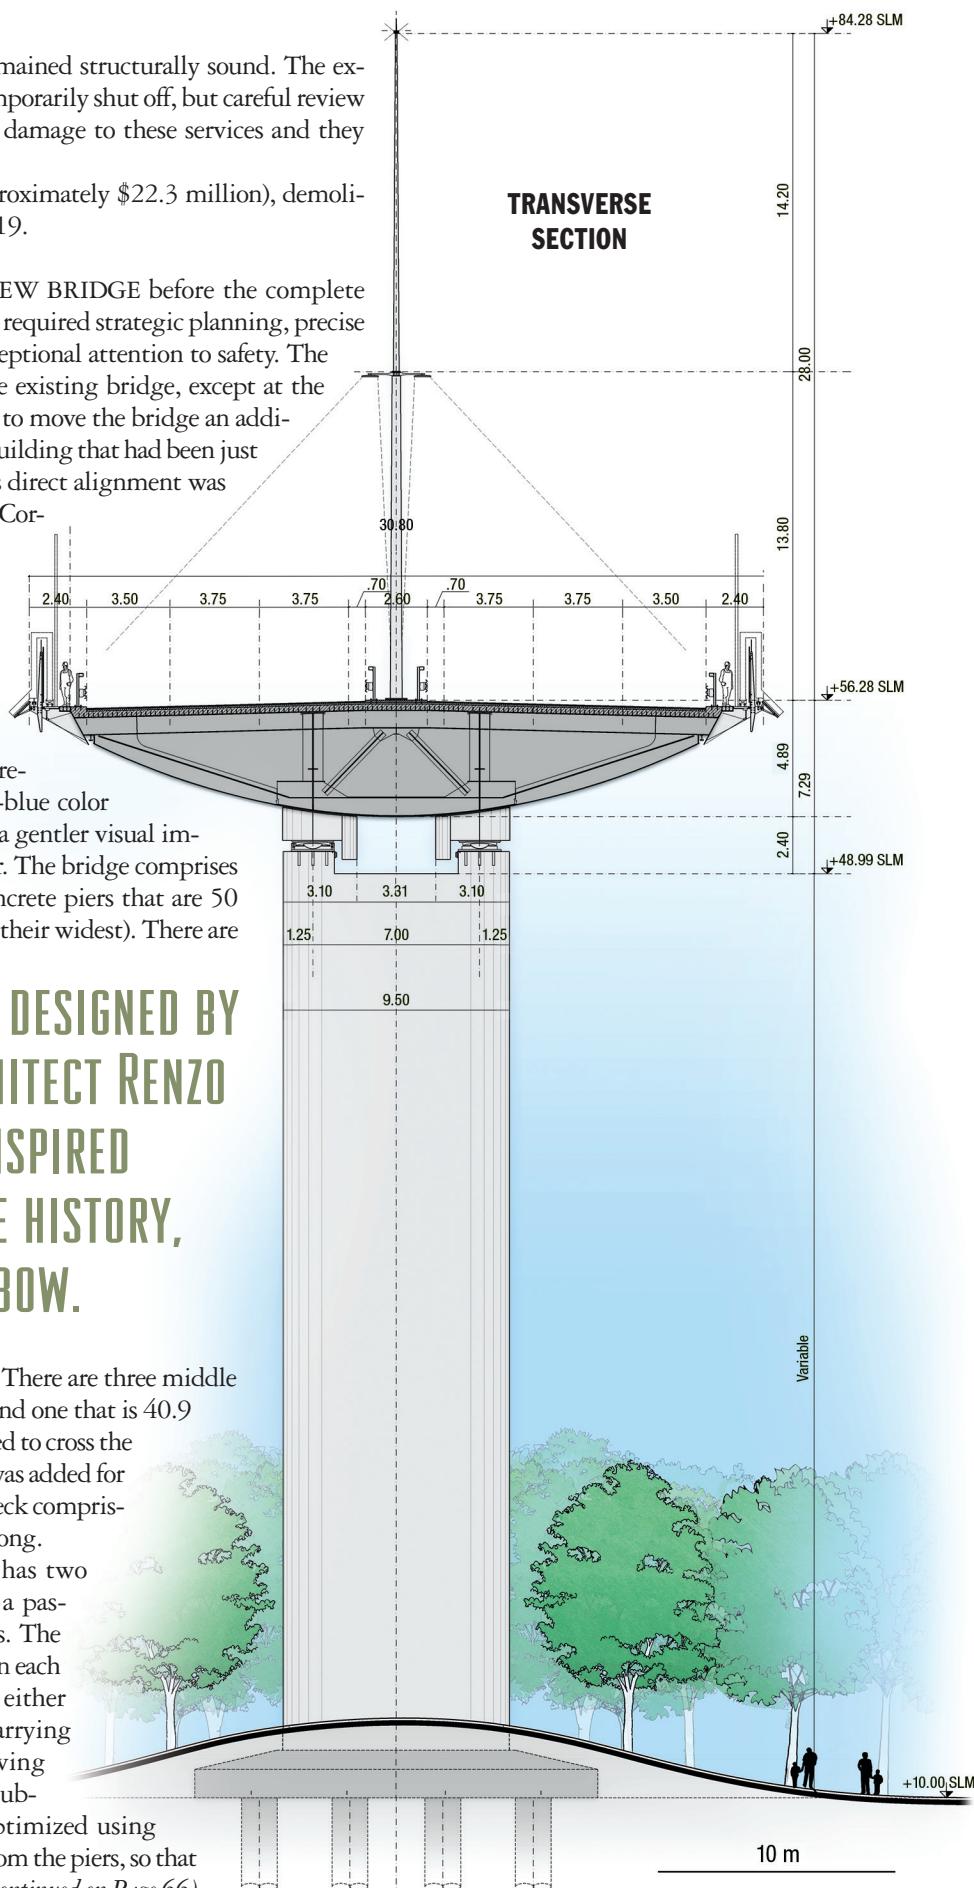
THE NEW BRIDGE WAS DESIGNED BY LEADING ITALIAN ARCHITECT RENZO PIANO. ITS DESIGN, INSPIRED BY GENOA'S MARITIME HISTORY, RESEMBLES A SHIP'S BOW.

The new bridge was designed free of charge by leading Italian architect Renzo Piano. Its design, inspired by Genoa's maritime history, resembles a ship's bow. Bright steel reflects the sunlight, and its pale gray-blue color blends with the skyline, resulting in a gentler visual impact on the valley than its predecessor. The bridge comprises 18 elliptically shaped, reinforced-concrete piers that are 50 m tall, 9.5 m wide, and 4 m thick (at their widest). There are

The central body of the bridge has two sides (wings), and each section has a passage inside for maintenance activities. The bridge has six lanes: two travel lanes in each direction and an additional lane on either side for emergency traffic and for carrying out maintenance work without having to close traffic lanes. The structure, sub-structures, and foundations were optimized using support devices to separate the deck from the piers, so that the bridge can naturally expand (Continued on Page 66)
